NKU-08-2021 Precast Wall Panel Repairs (Existing Conditions)

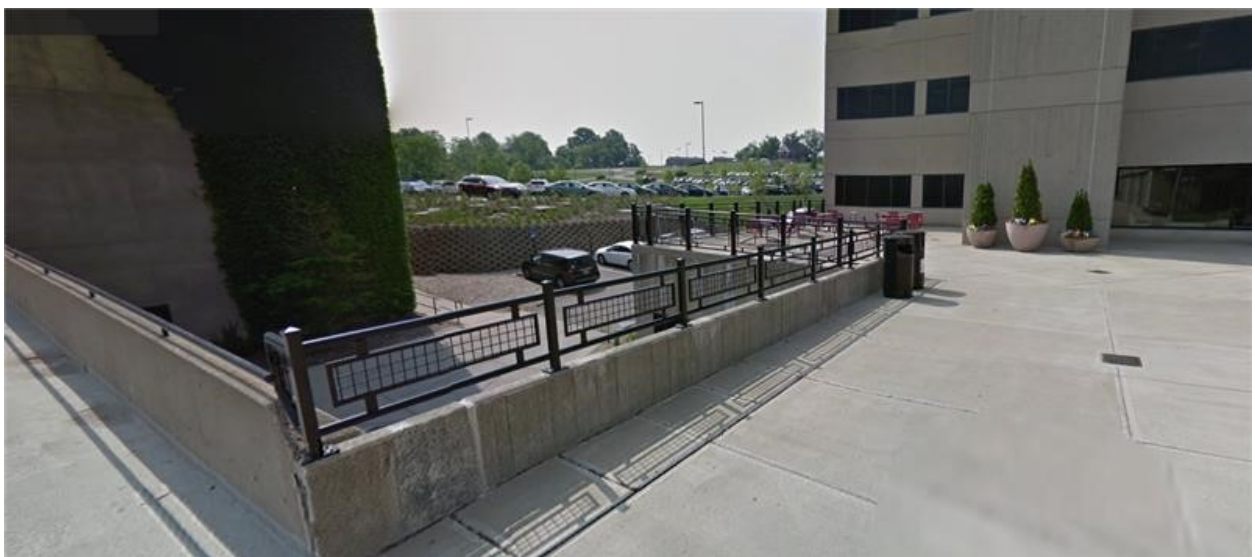
Photo at Bridge, ponding conditions
