Field Report

Date: February 24, 2021 **THP #:** 20035.00
Project: NKU Woodcrest Apartments **Field Report No.:** 19
Monitoring Program

Location: Woodcrest Apartment Complex

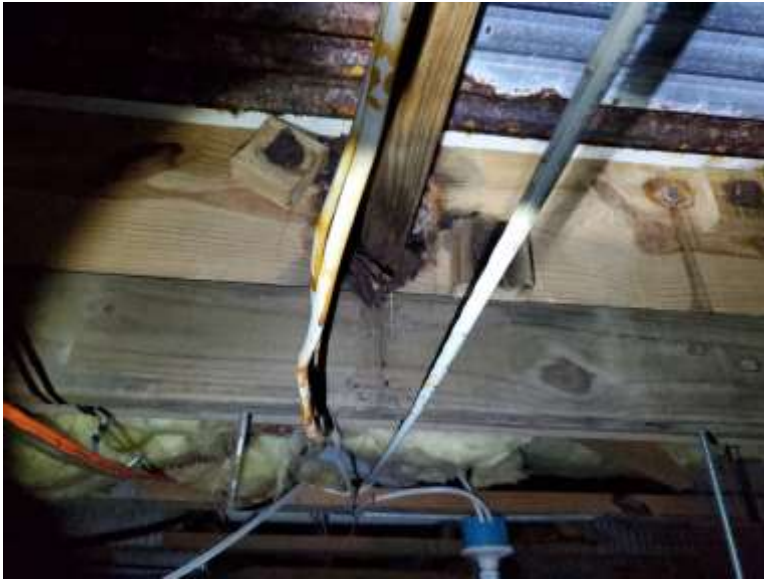
3. Oak Building: Joist hangers were noted to be deteriorated at a total of 8 location in the crawl space.

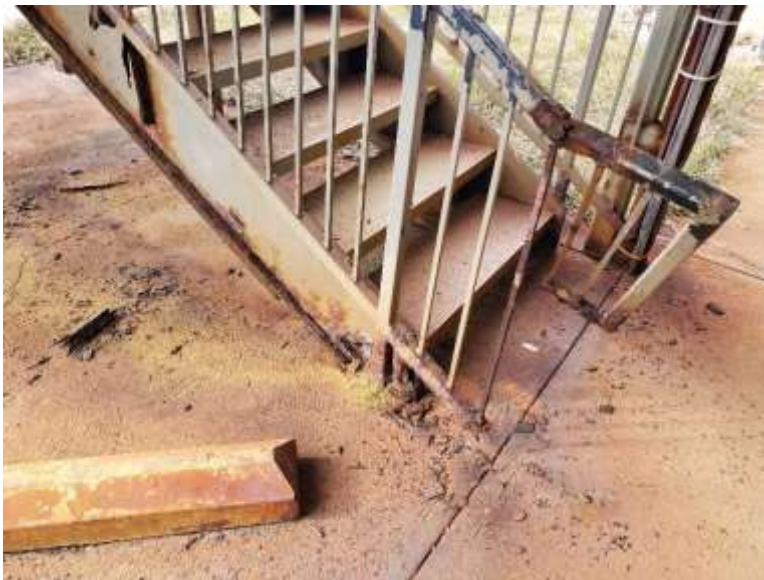
4. Oak Building: The railing along the back middle stair (south side) is corroded and needs supplemental reinforcement at 3 rail bases and at the bottom return.

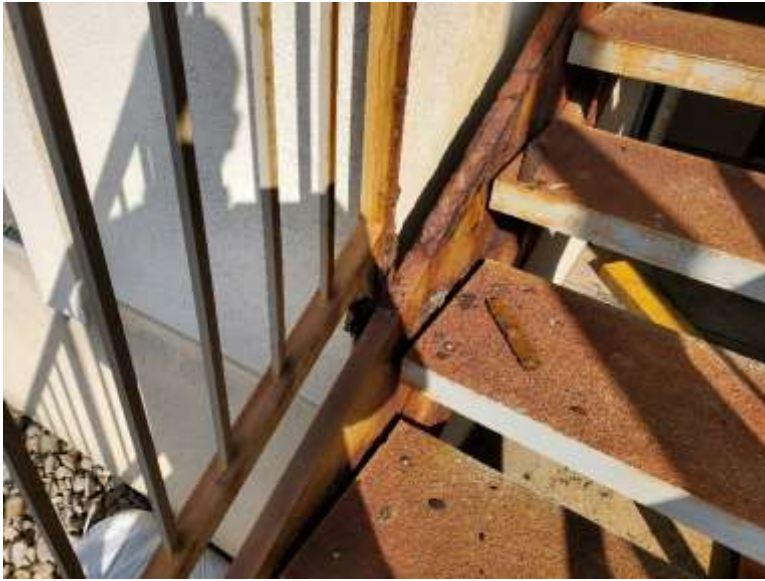
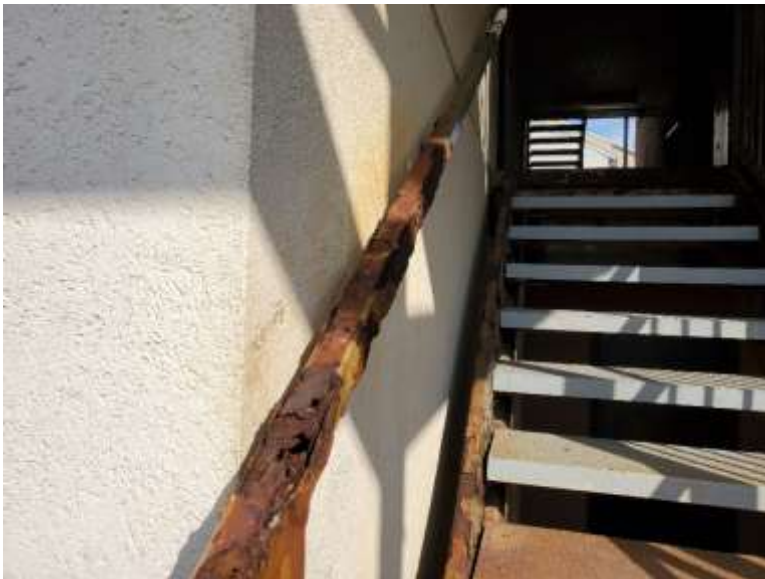
5. Oak Building: A railing along the back west stair (south side) is corroded and needs supplemental reinforcement.

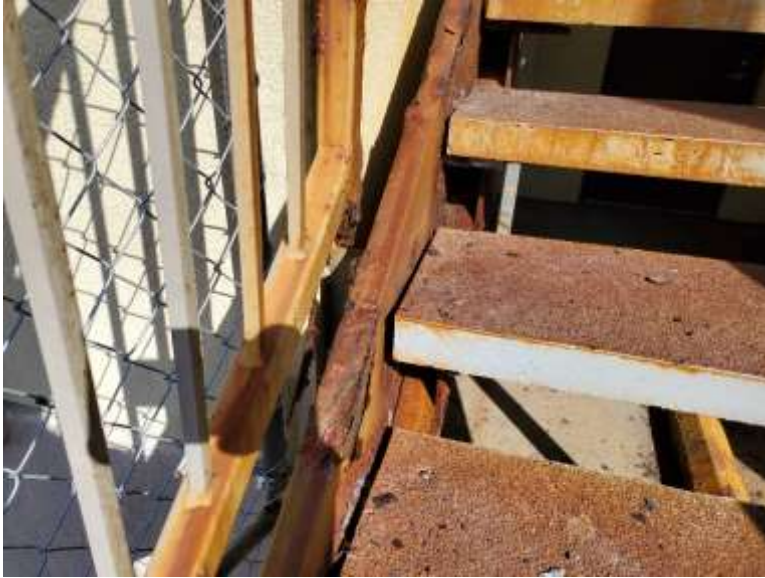
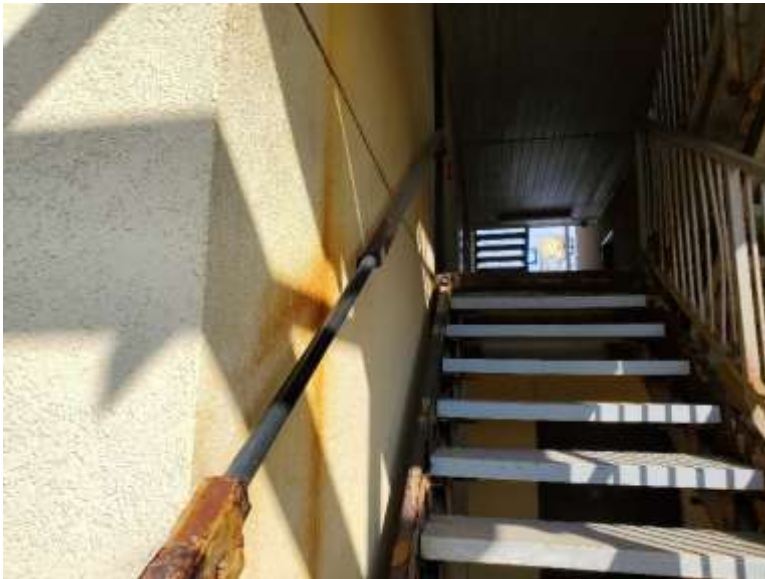
6. Oak Building: A railing along the back east stair (south side) is corroded and needs supplemental reinforcement.

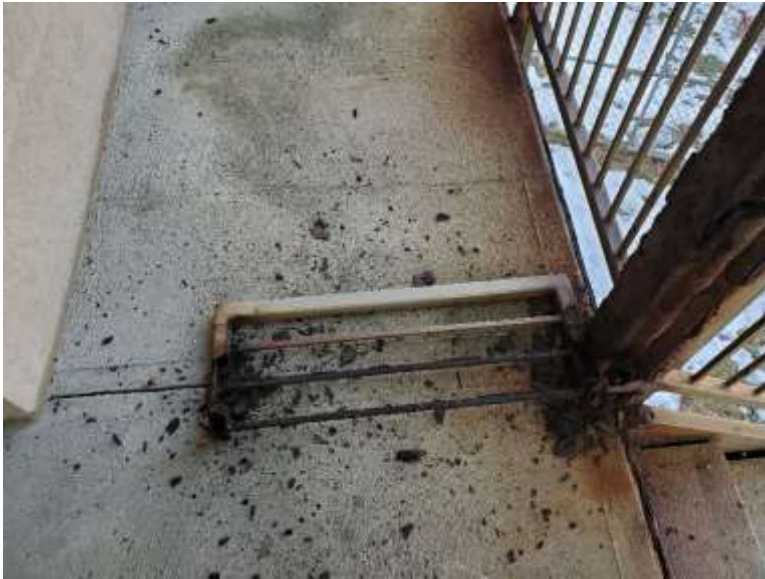
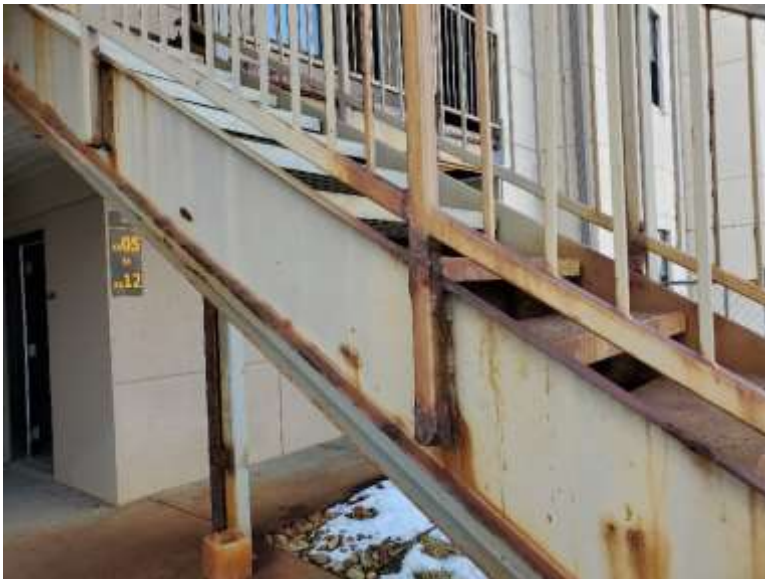
7. Oak Building: The railing along the front middle stair (north side) is corroded and needs supplemental reinforcement.

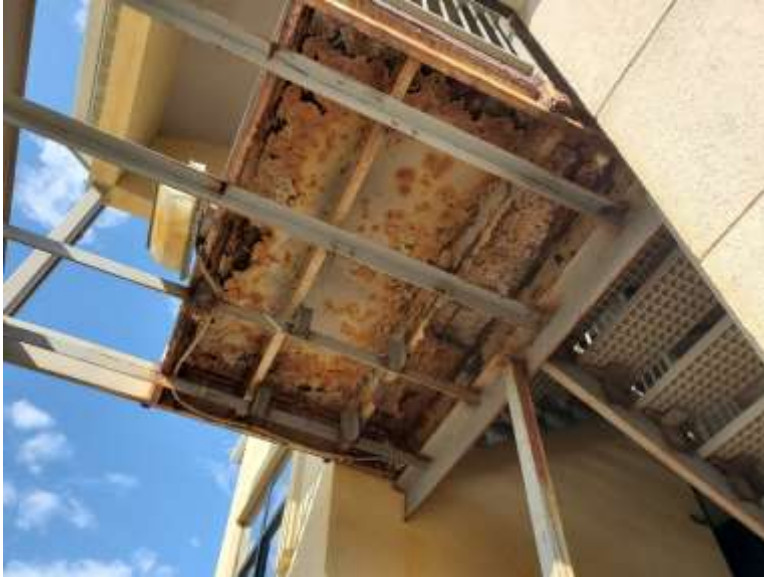
8. Oak Building: The remaining metal pan landings have further progressed in deterioration. No additional concrete spalls or missing pieces of concrete were noted. Photo is from the back (south side) east stair.

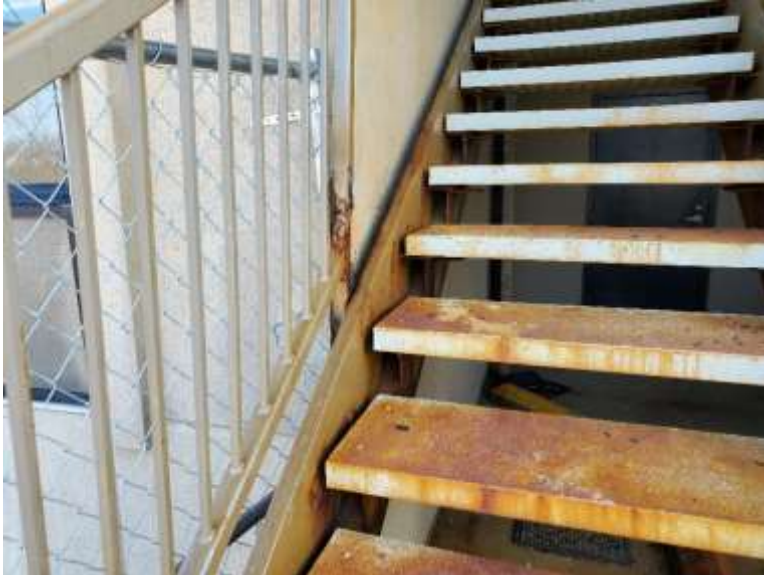
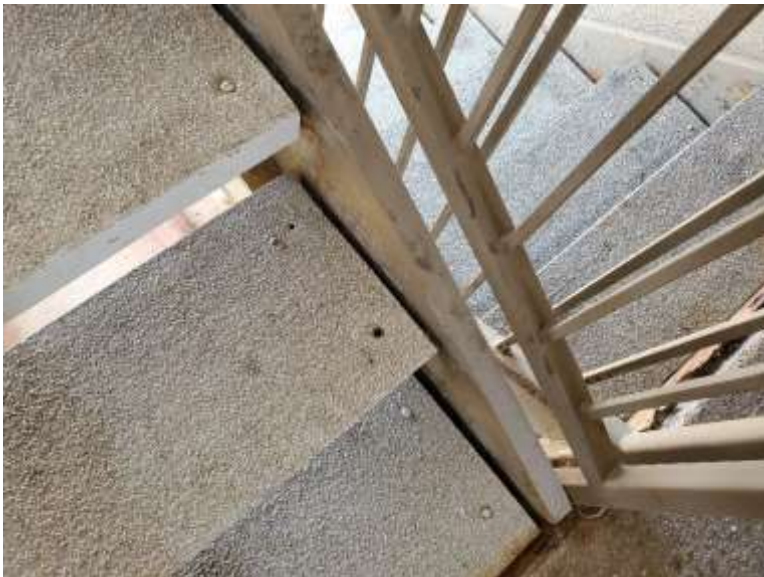
9. Sycamore Building: The railing along the south back stair (west side) has deteriorated at the rail base and along the top rail, railing should be reinforced, and there are 2 loose steps that need to be re-anchored down.

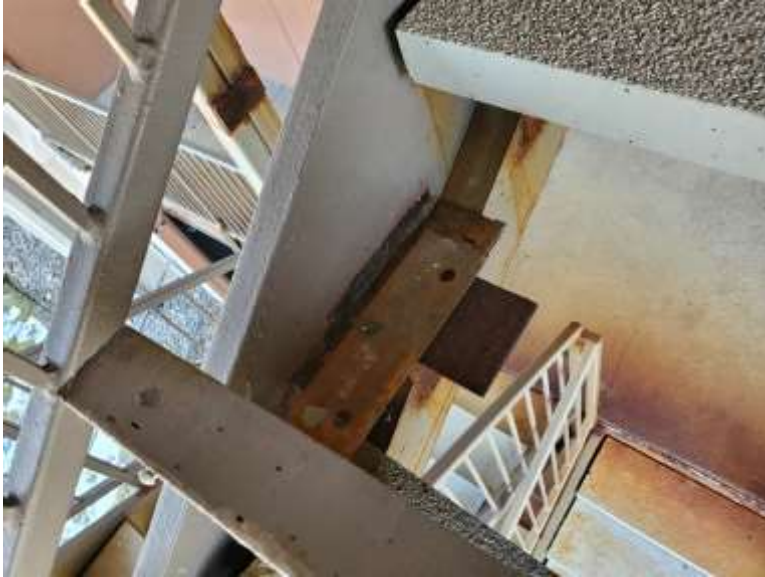
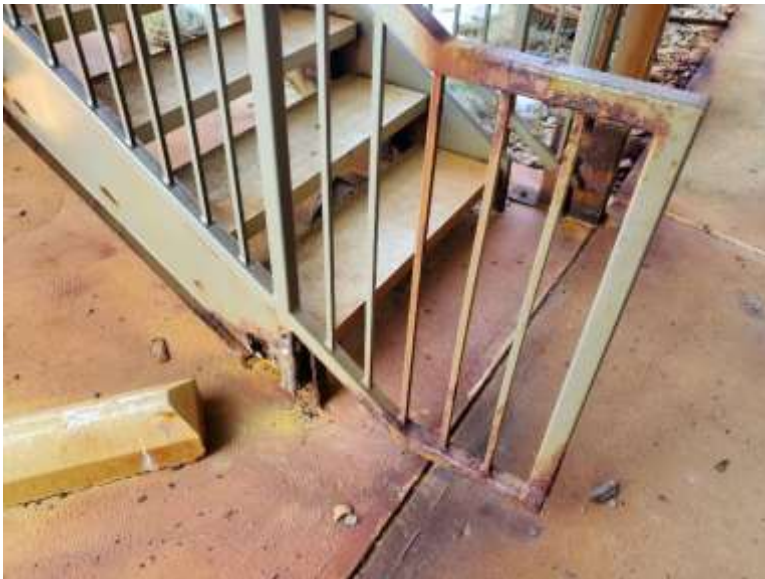
10. Sycamore Building: The railing along the back middle stair (west side) has deteriorated at the rail bases and along the top rail, railing should be reinforced, and there is 1 loose step that need to be re-anchored down.

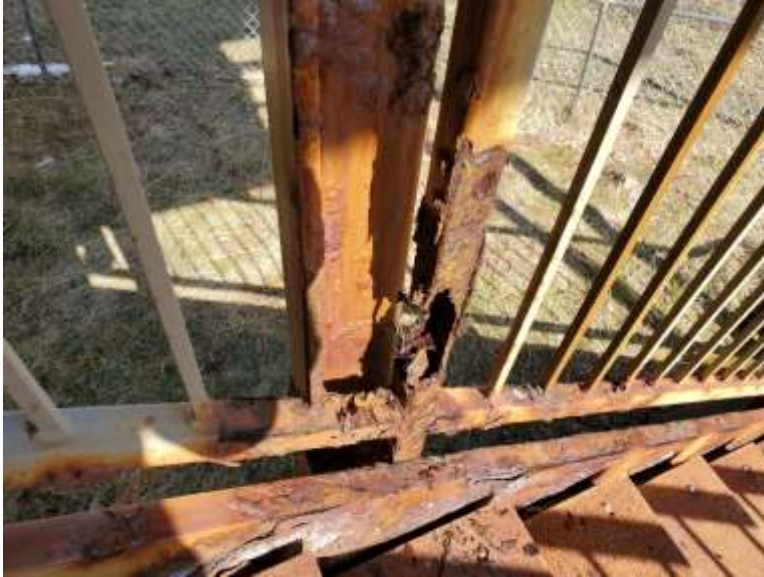
11. Sycamore Building: The railing along the front middle stair (east side) has deteriorated severely along the first run of stairs with the rail returns broken off, multiple holes in the top and bottom railing, and deteriorated rail bases. Railing should be reinforced.

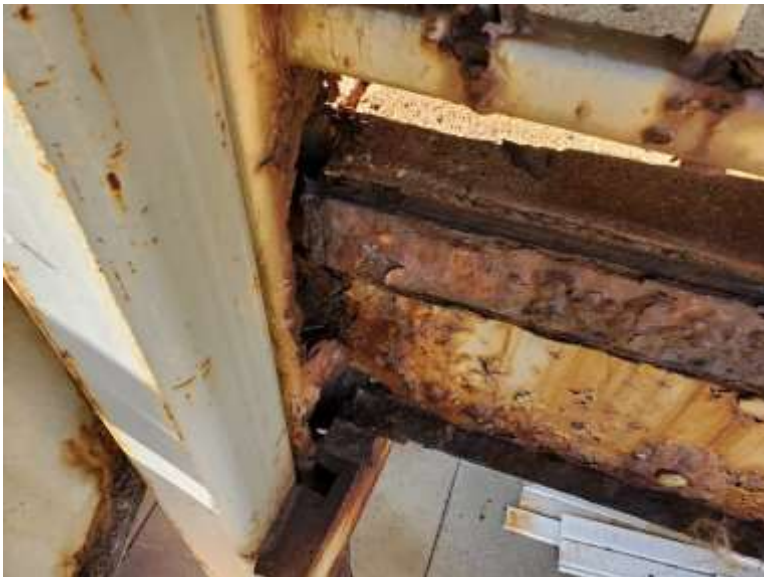
12. Sycamore Building: The front middle stair (east side) channel connecting the balcony walkway to the column is severely deteriorated with a 3Lf hole in the column. The connection to the previously installed reinforcing column is deteriorated and should be reinforced.

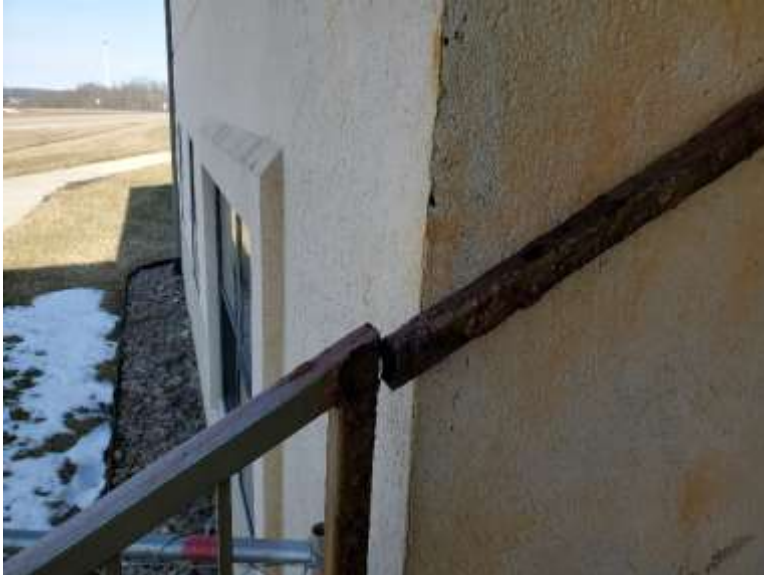
13. Sycamore Building: The railing along the north back stair (west side) has deteriorated split at the vertical post connection. Reinforce railing at rail base and to reconnected railing pieces.

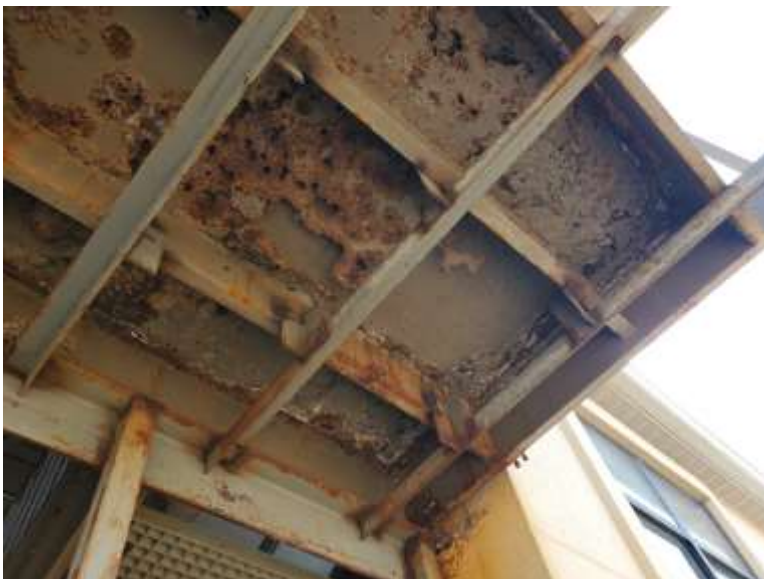
14. Sycamore Building: The remaining metal pan landings have further progressed in deterioration. No additional concrete spalls or missing pieces of concrete were noted. Photo is from the back (west side) south stair.

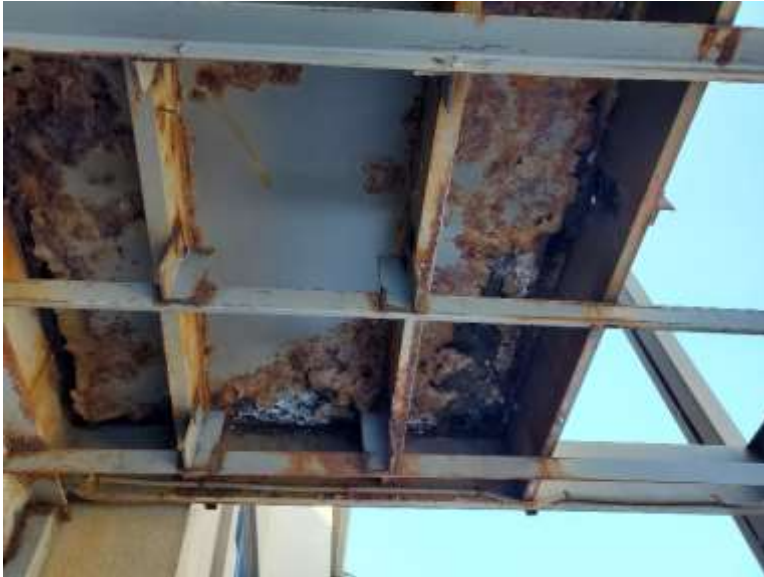
15. Willow Building: No new issues were noted at north side far west stair.
16. Willow Building: The remaining metal pan landings have further progressed in deterioration. No additional concrete spalls or missing pieces of concrete were noted. Photo is from the back west (north side) stair.

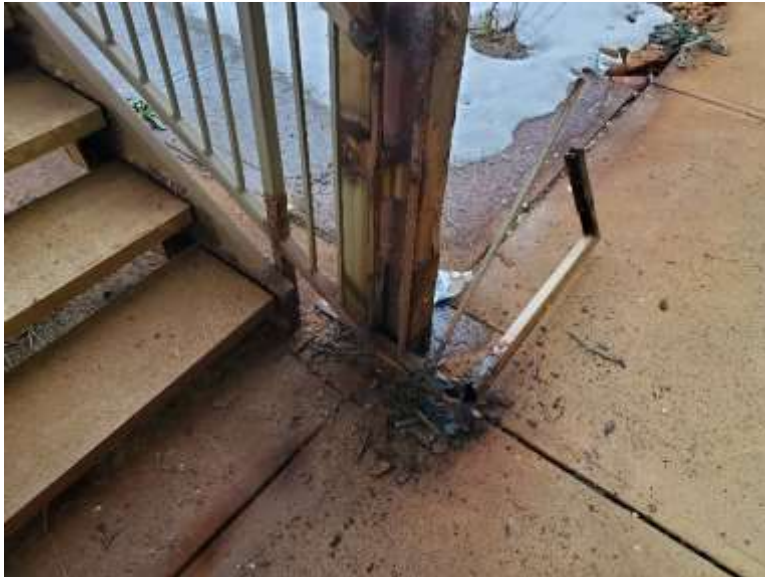
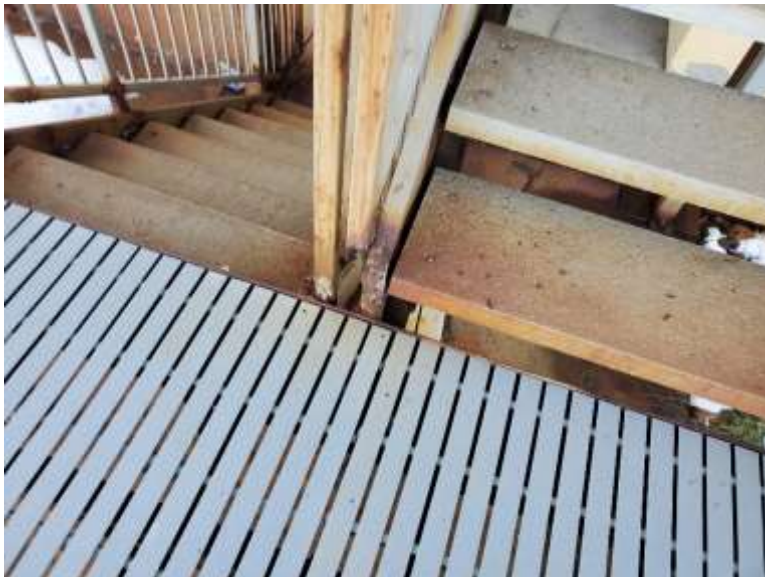
17. Willow Building: The railing along the middle back stair (north side) has deteriorated at each rail return, at multiple rail bases, and along the top of the railing. Reinforce railing at rail base and at rail returns.

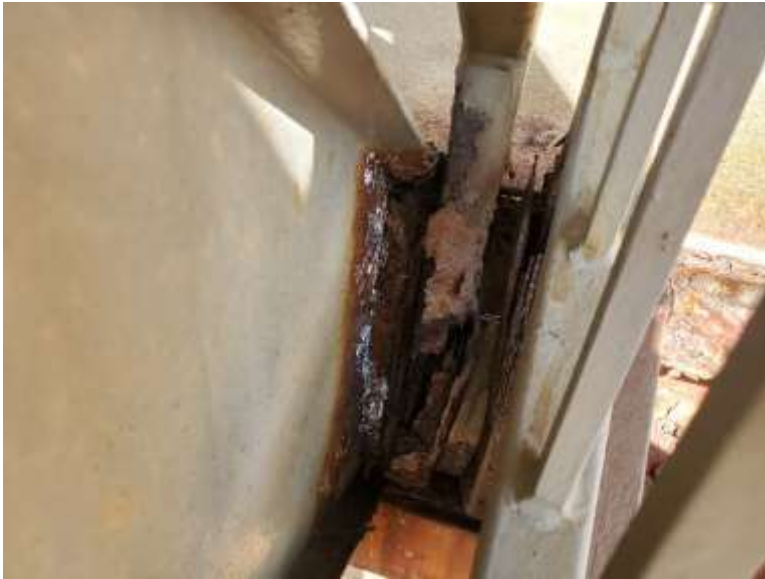
18. Willow Building: The railing along the middle front stair (south side) has deteriorated at multiple rail bases, and along the top of the railing. Reinforce railing at rail base.

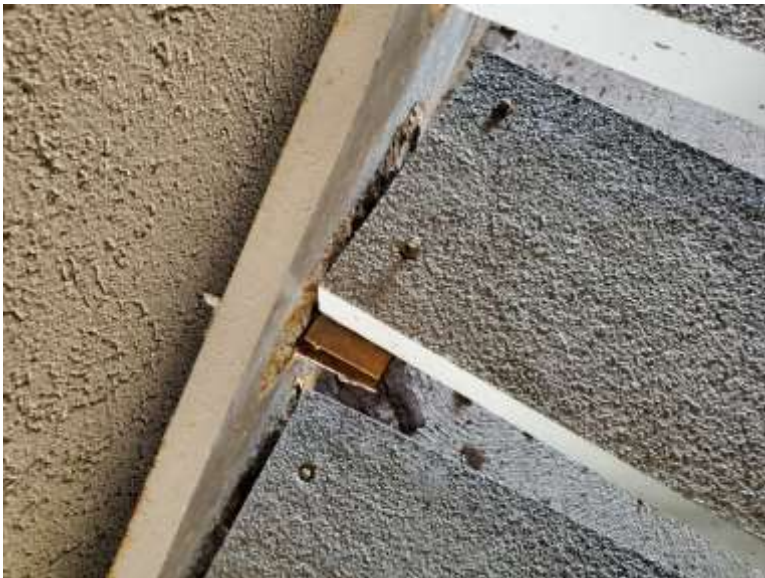
19. Willow Building: The railing along the back east stair (north side) has deteriorated at the rail bases and along the top rail, railing should be reinforced, and there are 2 loose steps that need to be re-anchored down.

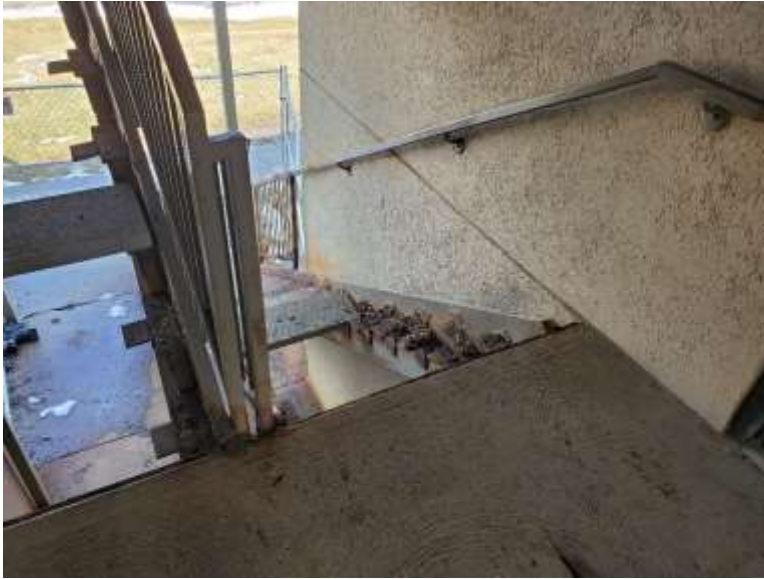
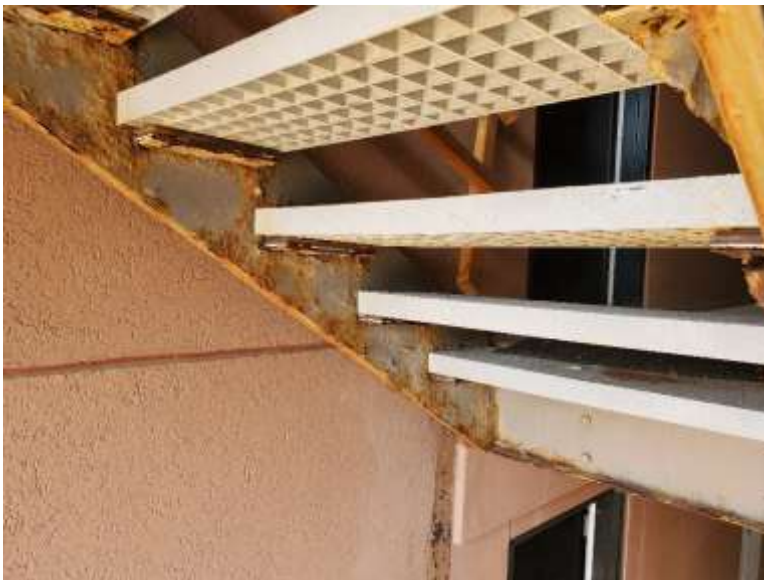
20. Willow Building: The steps along the back east stair (north side) have been removed. This stair should not be used unless NKU plans to reinstall the steps. THP review the front east stairs (south side), these stairs may be used at limited capacity as they were previously closed and not reinforced (second Photo).
